Environmental Impacts Assessment of Chromium Minings in Bulqiza Area, Albania

Abstract

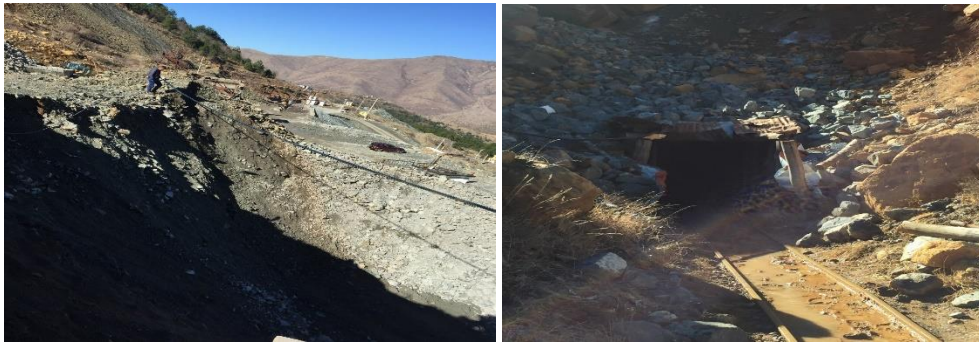
Opening the new ways to reach new galleries and opening up new chromium careers has led to the remove of the upper productive layer of soil (the main layer of physical, chemical and biological activity). As a result of surface interventions and in depth excavations for the extraction of chromium ore, soil deforestation and stripping of the soil surface has occurred, causing the phenomenon of erosion and the total soil degradation to appear massively. Improper disposal of the material (chrome ore and sterile - inert waste) to the storage squares around the mines and the galleries has led to the creation of "mountains" with mineral chromium stocks and sterile waste that have caused soil contamination and degradation and damage to the visual natural landscape (Figure 1). Disposal of inert materials and wastes, etc., have contributed to the pollution of soil and water (surface and ground water) and soil degradation, the destruction and loss of biodiversity, degradation of the environment, demolition, discontinuation, destruction of the natural ecosystems and damage to the visual landscape.

Figure 1. Erozion, soil degradation and contamination by the sterile waste of chromite mines (Photos by E. Laçi)

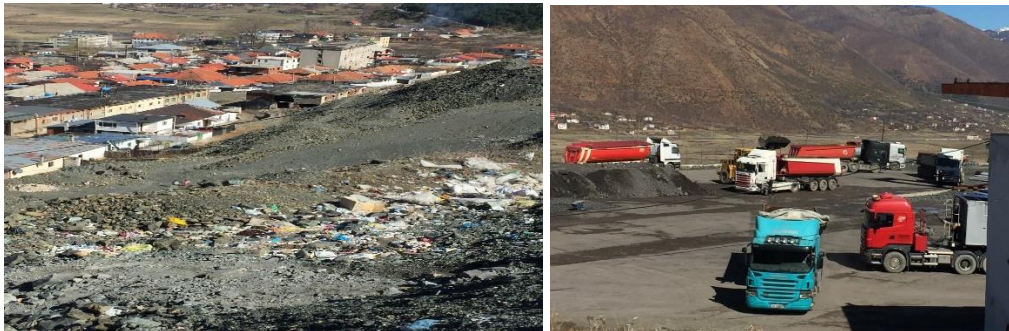
Around Bulqiza city, there are about 33 licensed and a number of unlicensed illegal subjects with exploitation and extraction of chromium ore activity. Field surveys and the results of the questionnaire conducted with residents (data not shown) indicate that heavy transport, loading and unloading machinery and mineral and sterile machinery - inert waste, cause continuous or periodic noise or vibrations in the town of Bulqiza, creating health problems For residents such as insomnia,

stress and mental fatigue. The main mine, opened since 1948, today under the administration of Albchrome Sh.pk, is located very close to the town of Bulqiza, as a part of it. Mineral resources from this mine, with a 70 years activity, as well as other mines around the town of Bulqiza, have been exploited indefinitely, creating horizontal underground hollows, as well as many abandoned galleries. The development of the mine activity is already happening under the city, which is accompanied by fears of residents for the collapse and partial loss of land and the city in case of earthquakes, as it is known as an area with a very high seismic activity (Figure 2). The phenomenon has also led to the destruction and damage of wild flora and fauna, removed due to noise and vibrations, interruption of the natural landscape and destruction of their natural habitat.

Figure 2. Soil and water pollution, and acoustic pollution by the move of heavy vehicles (Photos by E. Laçi)
